# FARMING IN THE FLOODPLAIN PROJECT FINDINGS AND RECOMMENDATIONS REPORT

Prepared for  
PCC Farmland Trust

Prepared by  
Environmental Science Associates

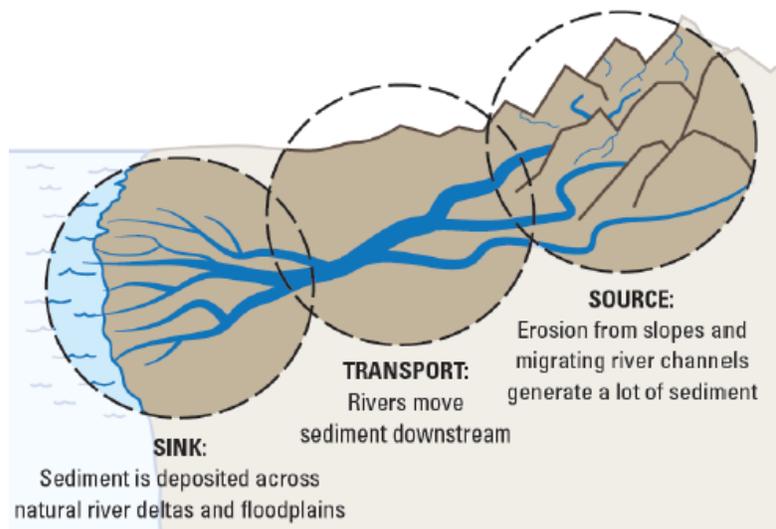
**Figure 2. Sediment transport. Source: Skagit Climate Science Consortium.**

Figure 2, provided courtesy of the Skagit Climate Science Consortium, shows how sediment enters and moves through a river system. Buildup of deposited sediment is called aggradation. Downtcutting in a river bed is called incision. Erosion and sediment transport in rivers and streams are part of a natural process. Coarse sediment deposited in rivers and streams creates spawning habitat; finer grained sediment deposited beyond the channels builds floodplains and forms beaches, deltas, and offshore habitats (Jaeger, 2016). Adding flood control measures and modifying the river system has changed how sediment moves through the river system. Natural erosion and sediment transport processes continue in this modified system although sediment movement can pose a range of challenges for people and aquatic organisms, including increased flood risk, damage to spawning habitat, buried vegetation and habitat, and turbid water (Jaeger, 2016).

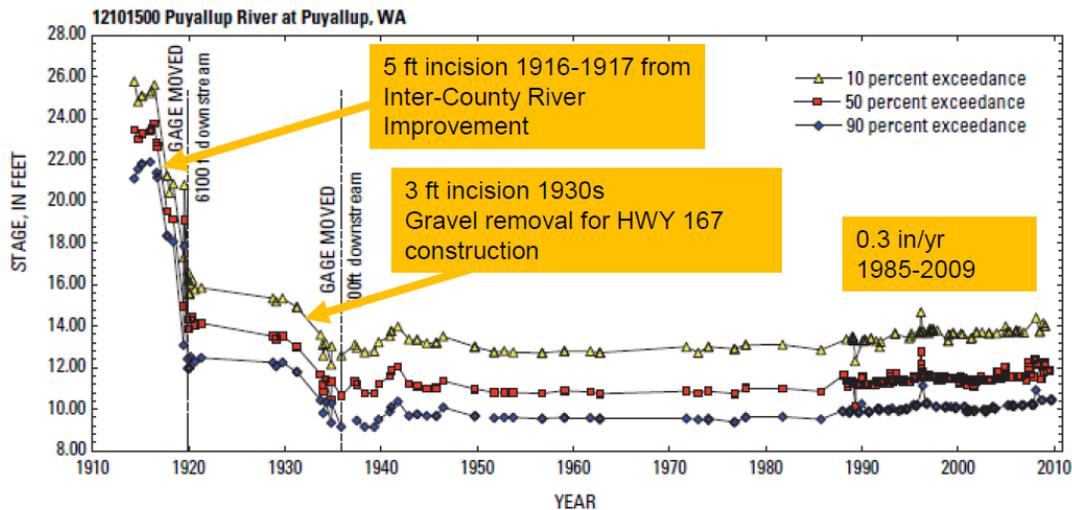
**Figure 3.** Stage for the period of record at 10, 50, and 90 percent exceedance for gaging station 12101500, Puyallup River at Puyallup, Washington. Source: Czuba et al., 2010.

Figure 3 shows the stage of three different high flow events in the Puyallup River channel modeled at the river gage near the City of Puyallup and how these elevations changed from around 1915 to 2010. The figure shows a 5-foot drop in the modeled water elevations between 1916 and 1917, due to the changes in the river bed associated with the Inter-County River Improvement project, which permanently diverted the White River into the Puyallup River. The figure also shows a 3-foot drop in the modeled water surface elevations in the 1930s associated with gravel removal in the river for the construction of Highway 167. Starting in the mid-1980s, the figure shows an increase in modeled water surface elevations of around 0.3 inches per year, which is attributed to aggradation of the river bed.

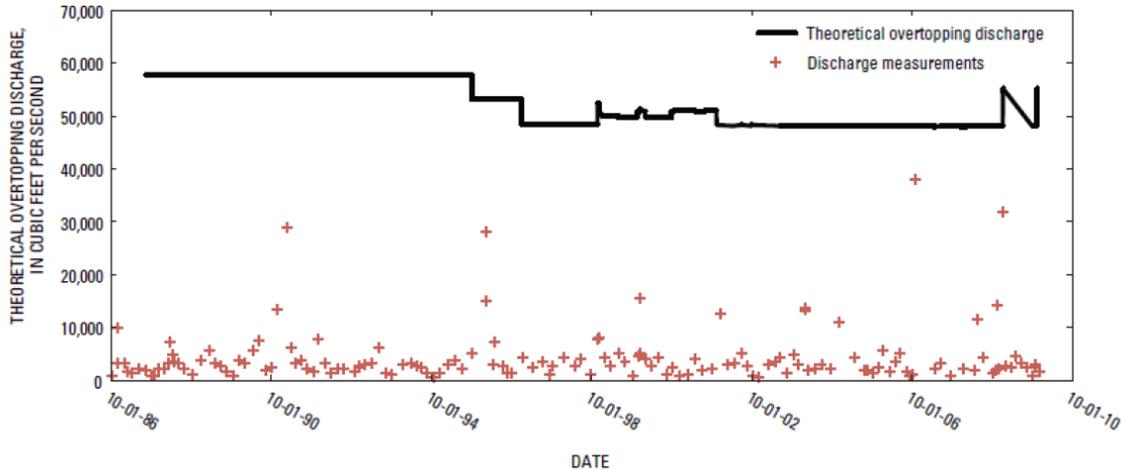
**Figure 4. Long-term trends in the theoretical overtopping discharge and discharge measurements at USGS streamflow-gaging station 12101500, Puyallup River at Puyallup, Washington. Source: Czuba et al., 2010.**

Figure 4 shows changes over time in the theoretical discharge at which the Puyallup River starts overtopping at the river gage near Puyallup. The theoretical overtopping discharge was estimated by USGS based on changes in the stage-discharge rating curves at the river gage. The theoretical overtopping discharge has decreased by about 9,700 cubic feet per second since 1987 due to aggradation in the river channel (Czuba et al., 2010).

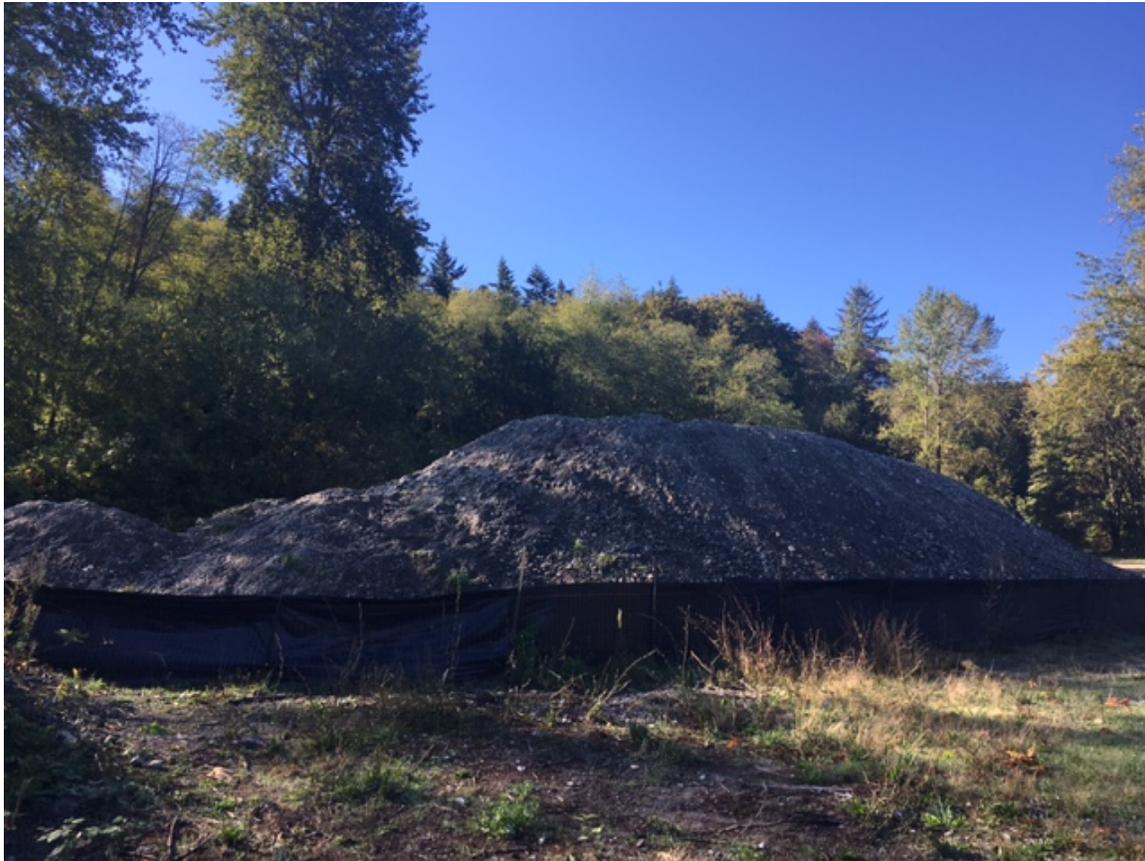
**Figure 6. Sediment removed from the Swan Creek sediment pond in 2016.**

The County removes sediment from the pond every 2 to 3 years. In 2011, for example, 2,400 cubic yards (cy) of sand and gravel plus 600 cy of silt were removed after 2 years of buildup (Pierce County, 2015). Figure 6 shows sediment removed from the sediment pond in 2016. Judi Radloff, the geomorphologist at GeoEngineers who did the sediment loading evaluation study, has stated that the sediment pond catches most of the sediment from Swan Creek, and much of the additional sediment that moves downstream of the pond is likely deposited in the City of Tacoma wetland site before reaching Clear Creek (Radloff, 2016). Primarily fine sediment suspended in the stream would be transported downstream of the wetland.

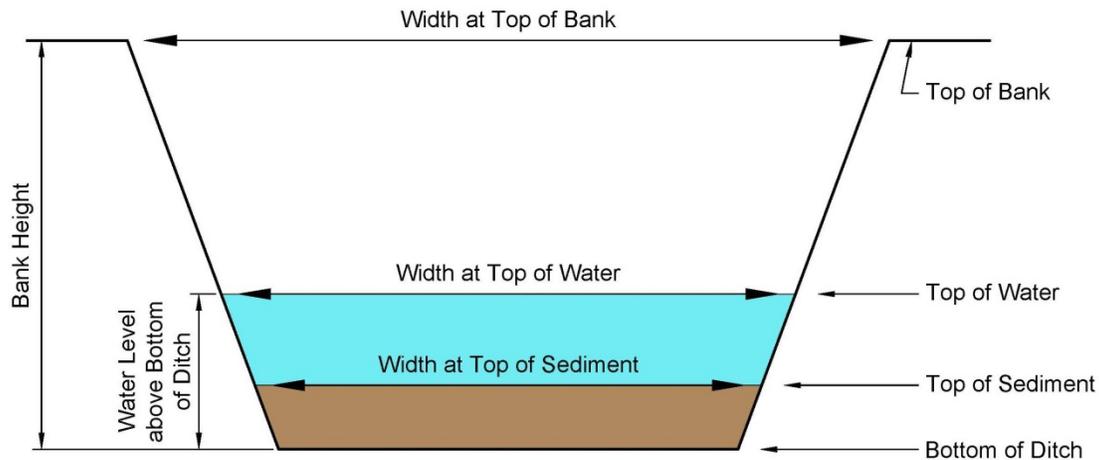
**Figure 2. Ditch Cross-section**

Figure 2 is a diagram of a ditch cross-section illustrating where measurements were taken by field investigators.

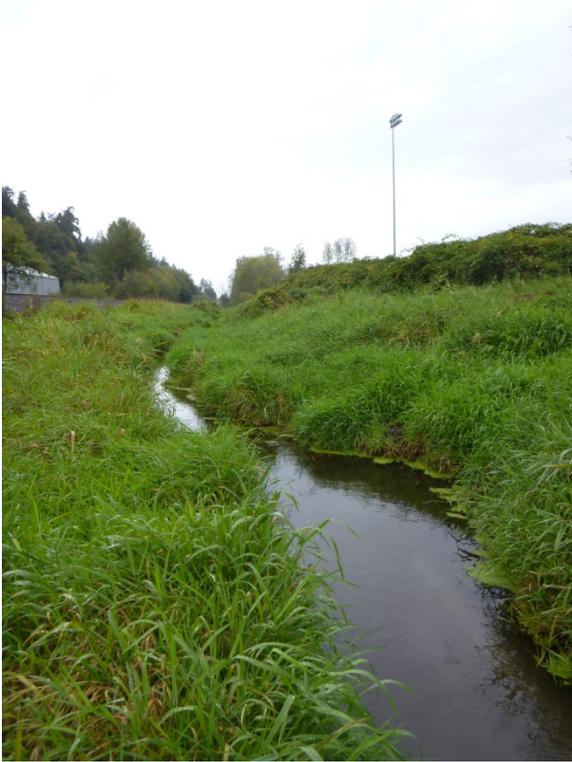
**Photo 1. Clear Creek facing downstream from the 52nd Street East culvert**

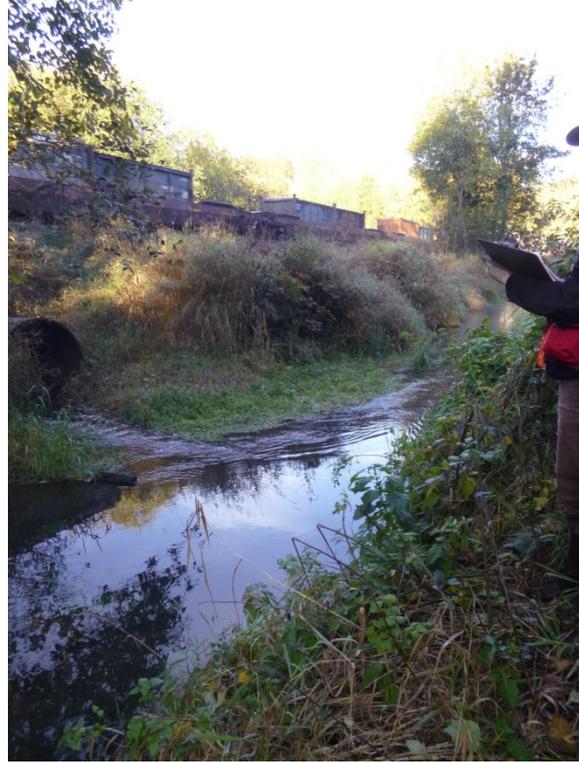
**Photo 2. Squally Creek flows through a culvert under the railroad tracks and into Clear Creek**

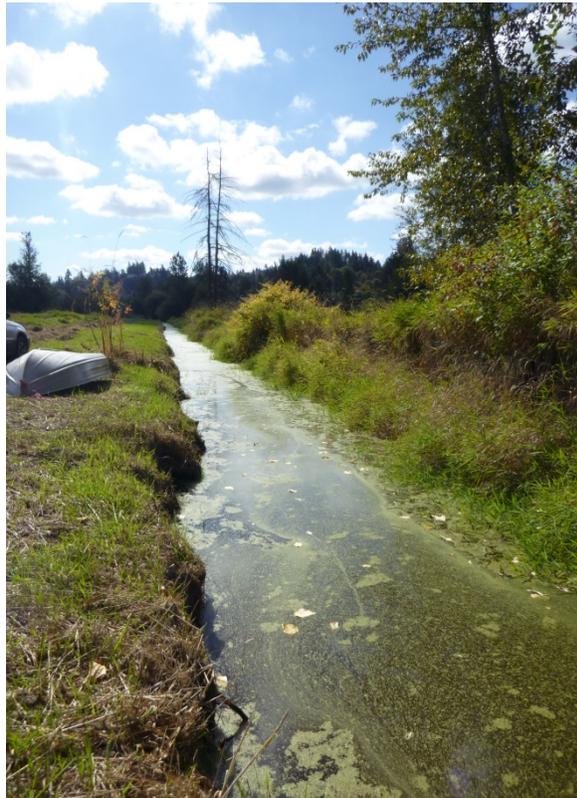
**Photo 5. North end of north-south reach of Nancy's Ditch, facing south.**

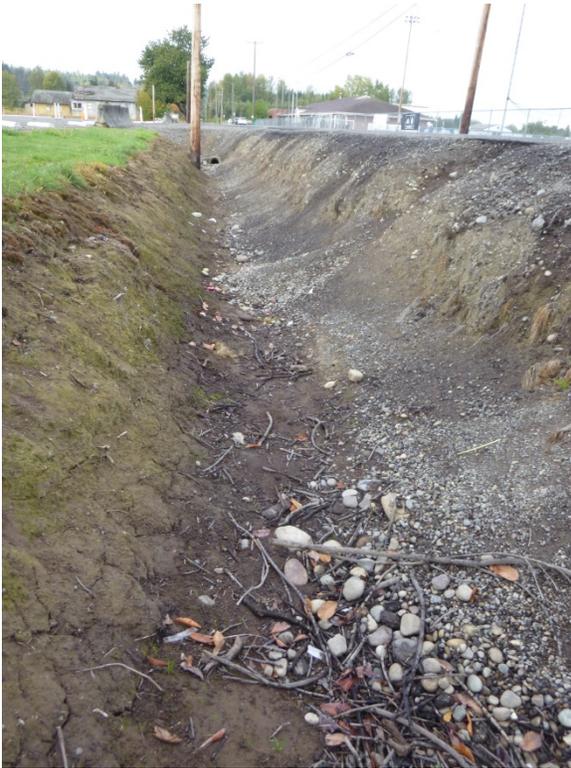
**Photo 9. 44<sup>th</sup> Street South Ditch adjacent to the soccer fields**

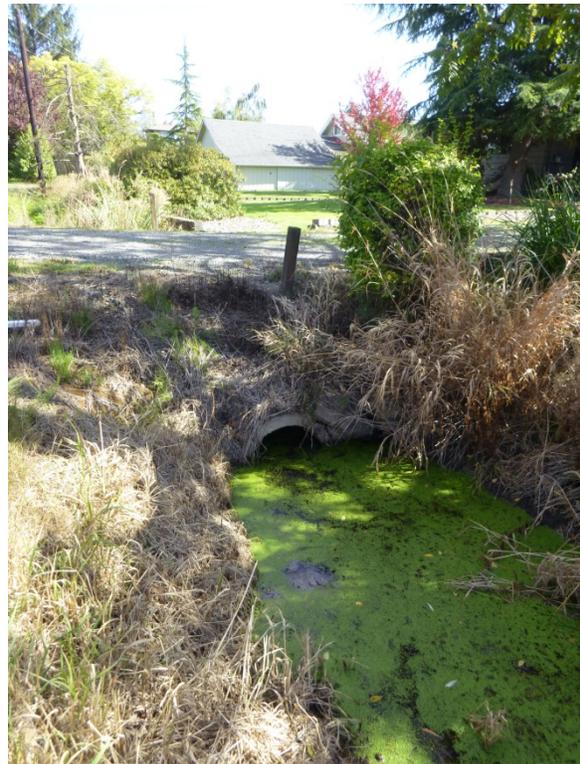
**Photo 10. 44<sup>th</sup> Street South Ditch and culvert, west of 50<sup>th</sup> Avenue East**

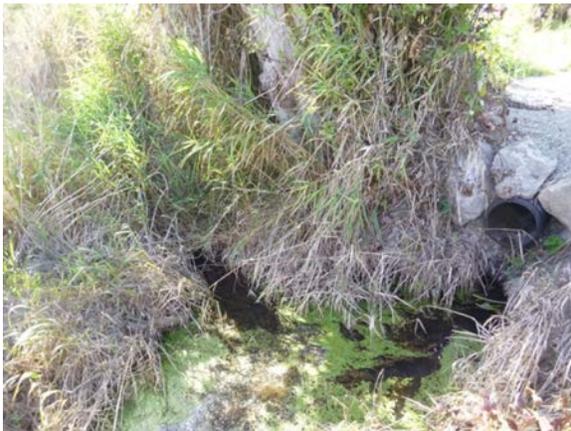
**Photo 11. Perched culvert in the 44<sup>th</sup> Street South Ditch. A second culvert that flows under the road and into the 44<sup>th</sup> Street North ditch is below it in the channel.**

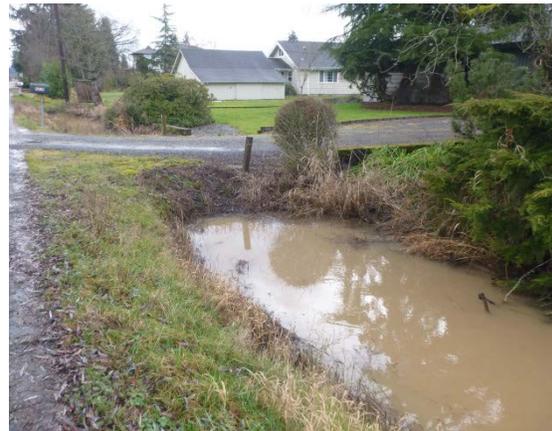
**Photo 12. Water levels above the top of a culvert along the 44<sup>th</sup> Street South Ditch, observed during the wet season site visit.**

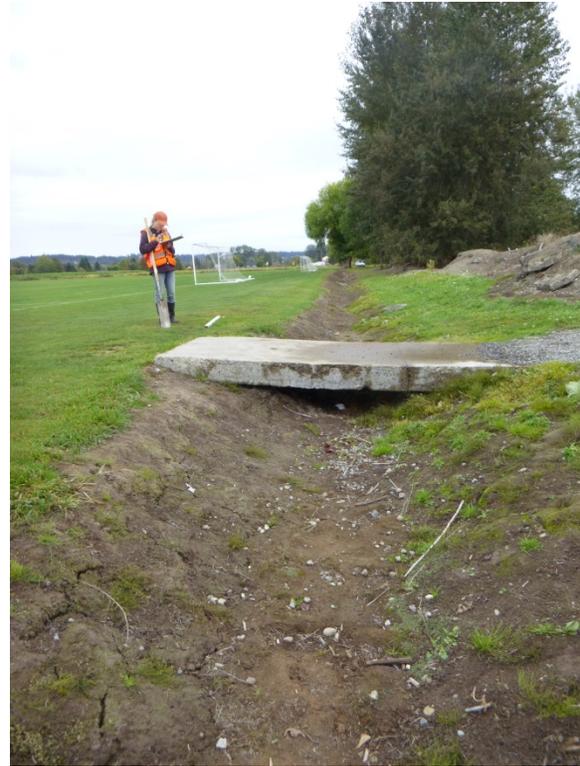
**Photo 14. South Ditch is maintained south of the soccer fields.**

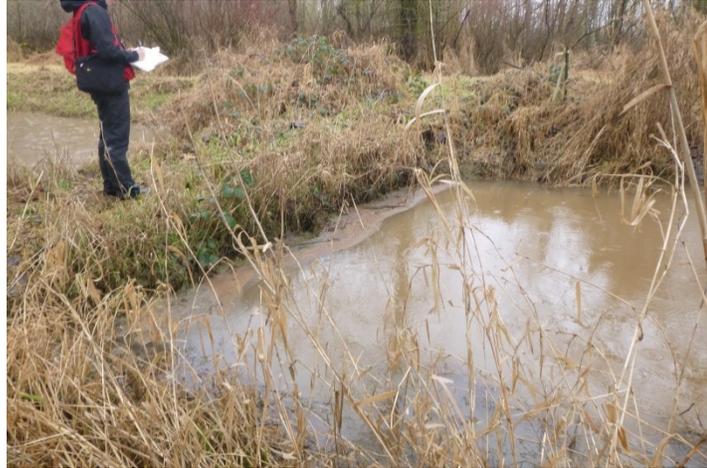
**Photo 19. Nancy's Ditch flowing through four culverts before entering Clear Creek on January 19, 2017**

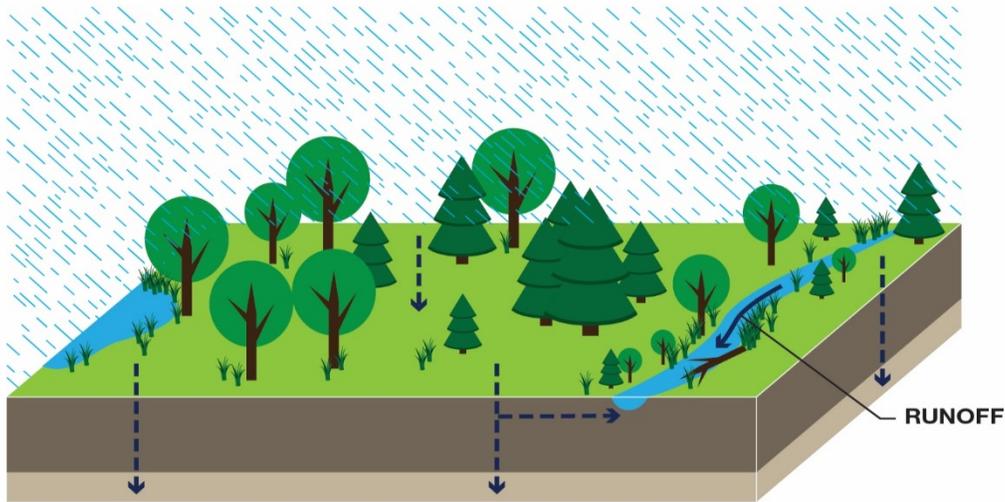
**Figure 2a.** Undeveloped Watershed.

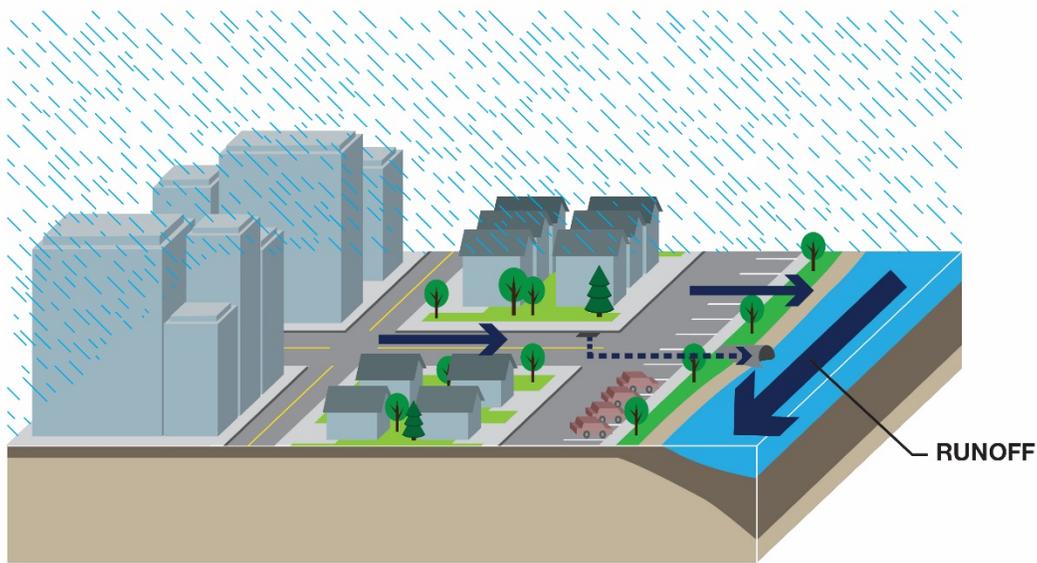
**Figure 2b.** Developed Watershed.

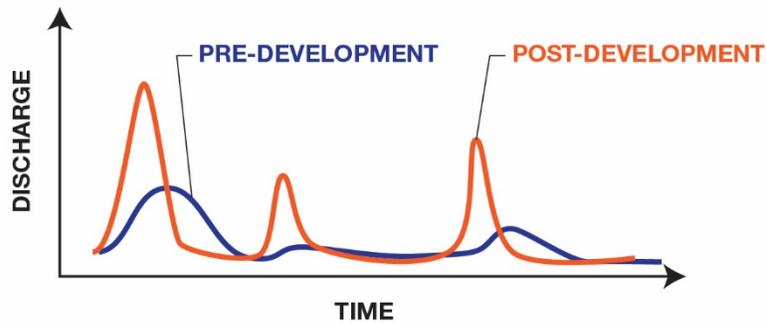
**Figure 2c.** Hydrograph of Stormwater Peak Discharges

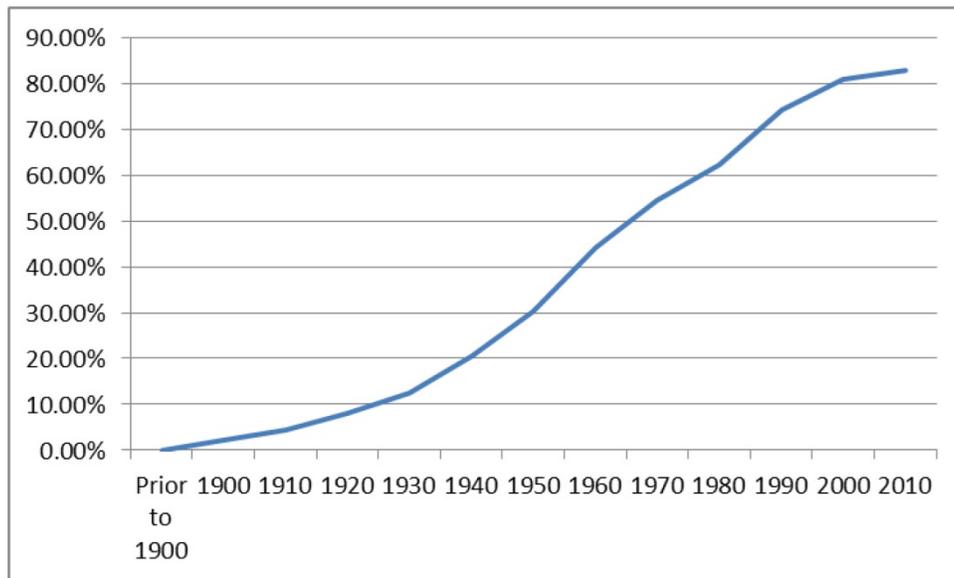
**Figure 3. Cumulative percent of developed parcels over time**
